# **Infrastructure Ontario and Ontario Science Centre Update**

July 11, 2024

## Structural Roof Assessment – Peer Review

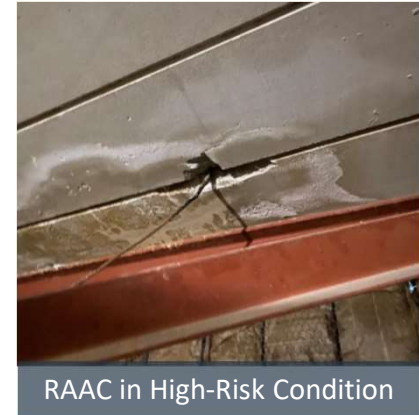
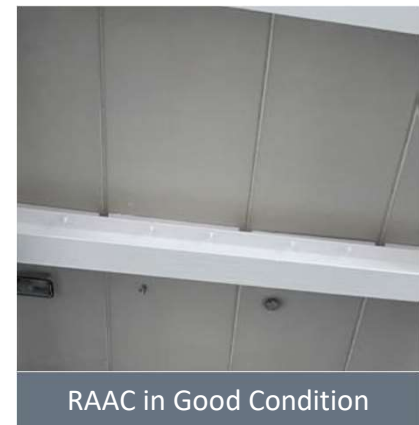
## Structural Roof Assessment – RAAC Details

- RAAC is a lightweight material susceptible to faster degradation over time due to increased water infiltration through the porous structure.
- The panels are typically 18 inches wide by either 5, 10 or 20 feet long.
- They are held in place by tension and gravity, with little physical connection or anchoring to secure them.
- Individual panels in a roof system will have varying levels of degradation, all of which contribute to the overall risk for the entire roof system. The risk is further compounded by the distribution of the panels and the condition of the entire roof assembly.
- Failure of the critical and high-risk panels due to snow load requires mitigation prior to October 31, 2024.

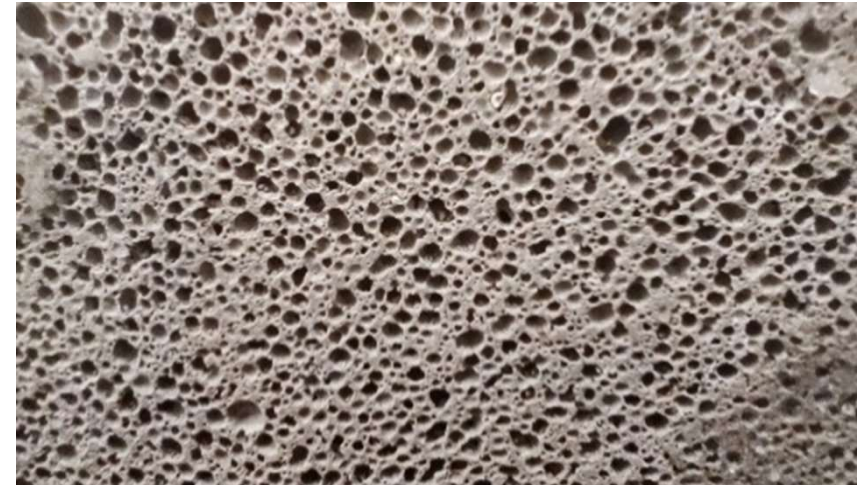
Sawn cross section of a typical RAAC panel  
(Loughborough University)

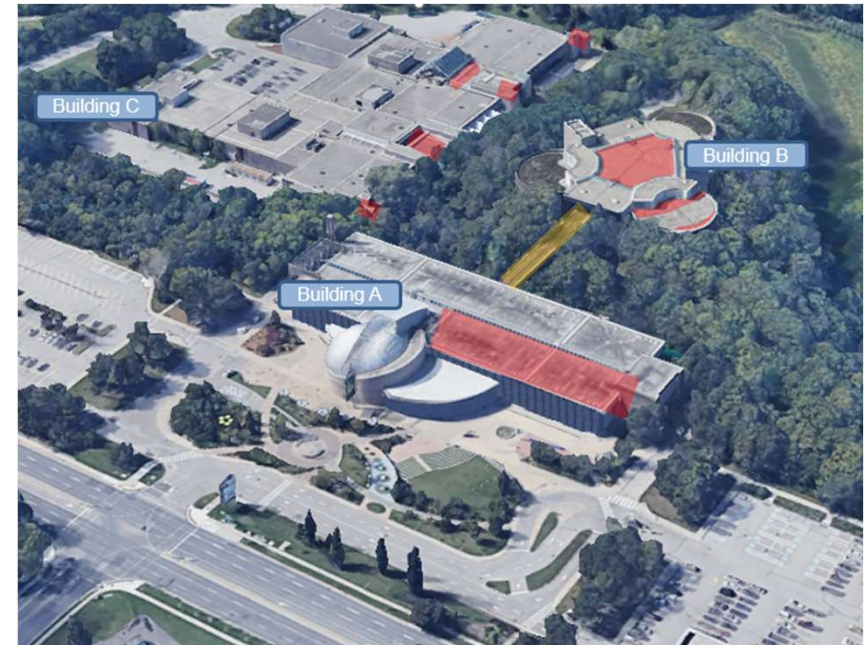
## Structural Roof Assessment - Continued Investigation Required

- Significant roof areas of approximately 24,200 square feet (28 per cent of Building A and 36 per cent of Building B) have not been investigated and would require closure to complete.

- In Building A, uninvestigated areas would require highly intrusive access through reinforced concrete which could cause significant impacts (i.e., vibration, structural shifting) to the existing RAAC panels, creating risk to occupants within the building.

- In Building B, the roofs above the Great Hall and Auditorium would both require:
  - Significant protective measures due to risk of disrupting asbestos, which must be contained.

- Large openings or complete removal of the finished ceiling would be required, with significant scaffolding built in place to provide the necessary platform to conduct inspection and abatement work.

- A recent roof leak in Building C occurred in an area adjacent to an uninvestigated area, which further reinforces the ongoing risk associated with the unknown condition of these areas.

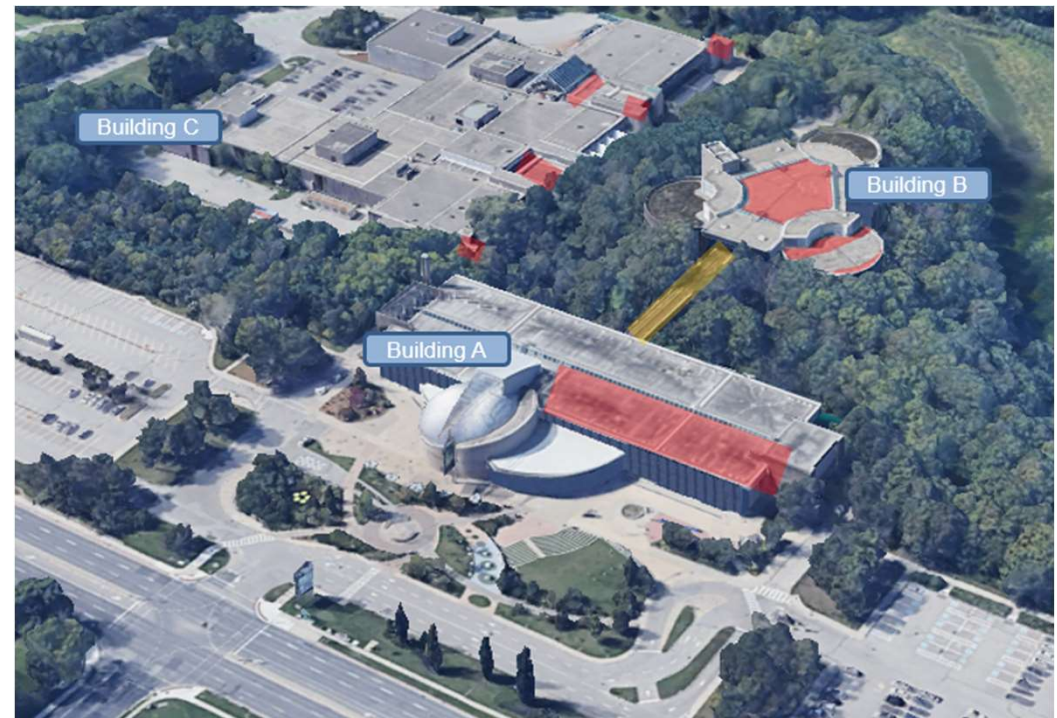
# Pedestrian Bridge

- The pedestrian bridge has been closed since summer 2022, due to structural integrity concerns. Since that time, the bridge has been monitored on an ongoing basis, and further investigations are underway.

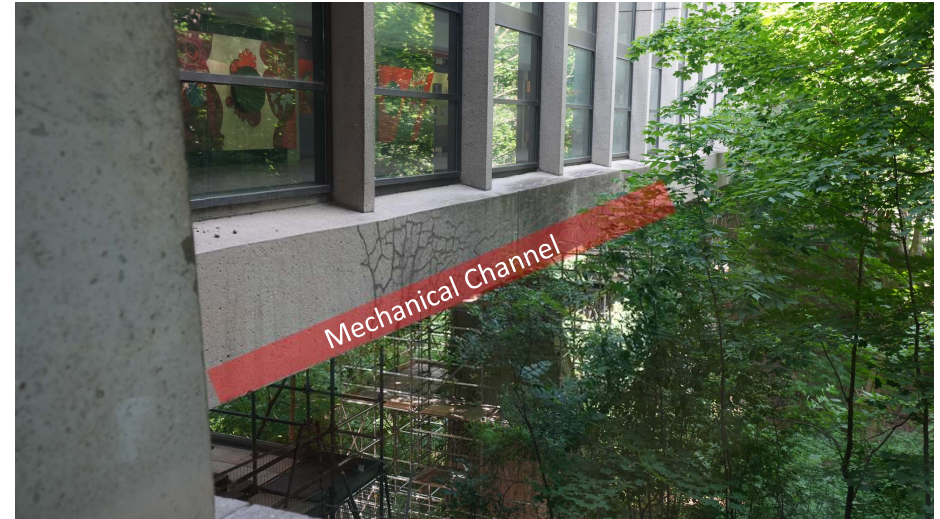
- The area between the edge of the building and the steep decline of the ravine is very narrow – approximately 5'-10'.
- As mentioned previously, all services to Building B run through a very small mechanical channel built into the pedestrian bridge, which is not currently accessible.

- Currently, there is **no heat in Building B** due to a malfunction of the heating pipes in this mechanical channel. This must be fixed before the winter season commences due to the potential for sprinkler system freezing, which creates fire safety risks.

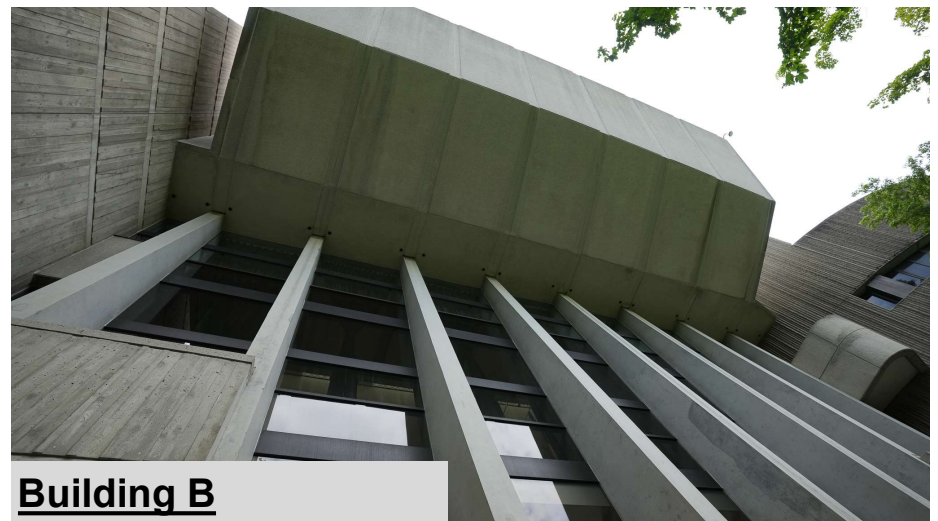
## Building A and B – Overhang

- Buildings A and B have decorative concrete overhang features tied into the roof assembly. This makes RAAC replacement significantly more challenging and costly than replacing a typical flat roof.
- In order to replace the RAAC panels in this area, the engineers have specified that the decorative concrete overhangs must be removed.
- Construction complexities for both buildings are due to:
  - Building A overhang is above the pedestrian bridge.
  - Building B overhang is above the window façade, which has less structural integrity than the poured-in-place concrete walls elsewhere.

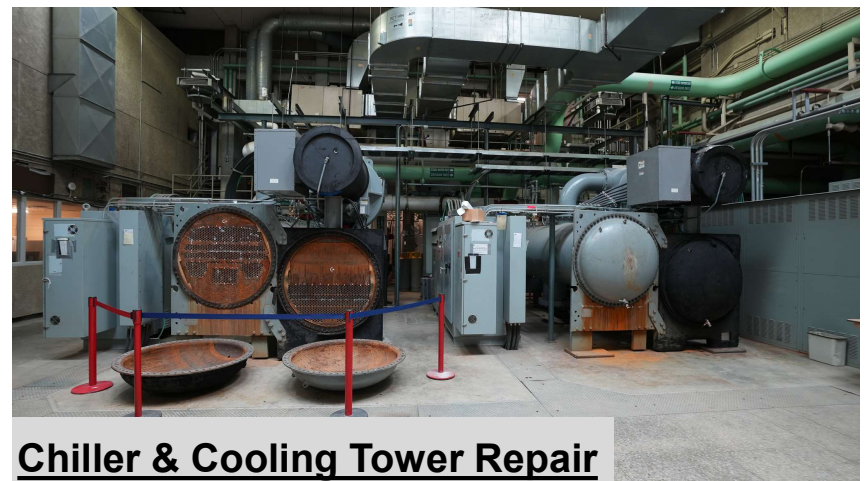
# Building A - Boiler Insulation Failure and Chiller Repair

- Building A is the mechanical and electrical hub for the entire facility. There is no longer any redundancy for cooling, heating or hot water supply.
- There is no guarantee that any of the operational equipment will last until October 31, 2024.
- Further to the 2022 Pinchin Report, the electrical systems are at the end of their useful life. Any reworking of this system, in addition to modernizing the building, would require new wiring throughout the decorative concrete walls.

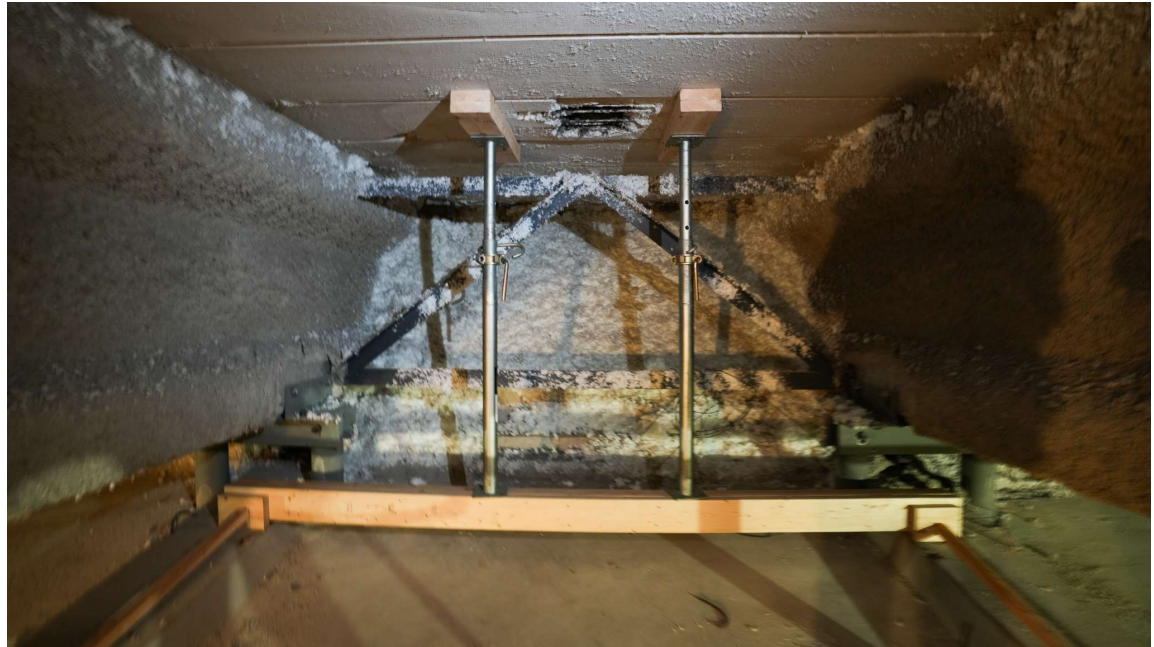
## Building A – Critical Panel Reinforcement

- This is a critical risk panel in Building A that required immediate reinforcement due to the level of deterioration.

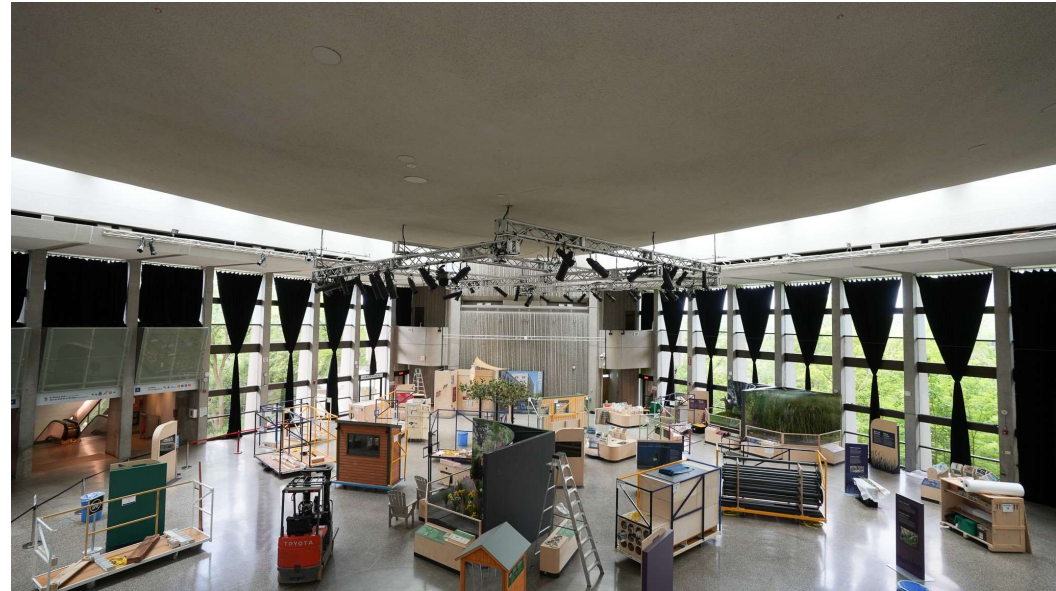
## Building B

- Approximately 80 per cent of visitors spend time in Building B.
- There is currently no heat, and the location is extremely challenging to access due to its proximity to a ravine, which makes bringing in materials and construction equipment extremely difficult.
- 36 per cent of this building has not been investigated for RAAC due to its challenging location over the exhibition space. It also has the highest concentration of high-risk panels in a single area.
- Skylights in Building B drain most of the water onto the Great Hall roof, which is an uninvestigated area of RAAC panels.
- Further complexity for RAAC investigation is the presence of friable asbestos which must be abated in-place.
